# Limited Turnover Inspection Report

Re: **Community, Limited Turnover Inspection Report**  
Project Number: MXXXXX

Miller Building Group, LLC ("Miller Building Group") was retained by Client to perform a limited turnover inspection at the property commonly known as Community, located in XXXXX, Florida. This inspection was performed in accordance with the *Retention Agreement* dated Date (Appendix IV).

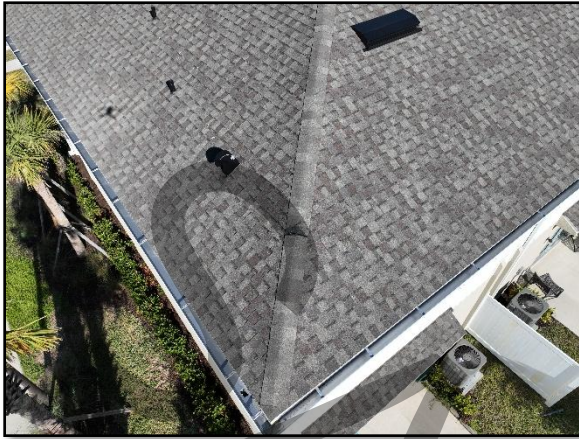
1 - Missing / slipped shingle(s). M19\_UAV(1393)

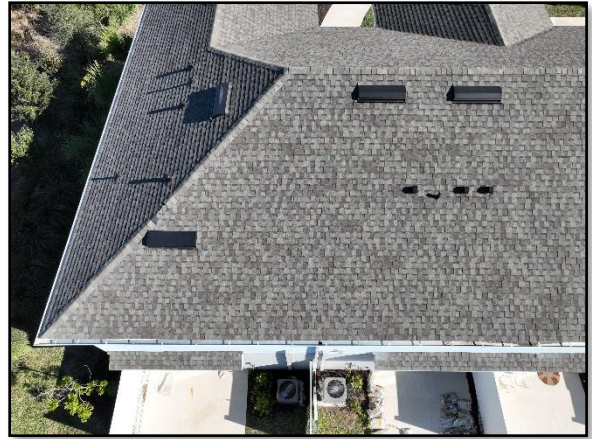
2 - Missing / slipped shingle(s). M19\_UAV(1474)

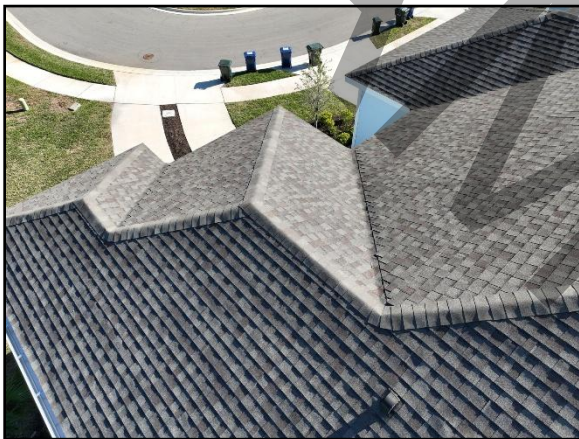
3 - Untrimmed shingle(s) at valley. M19\_UAV(1485)

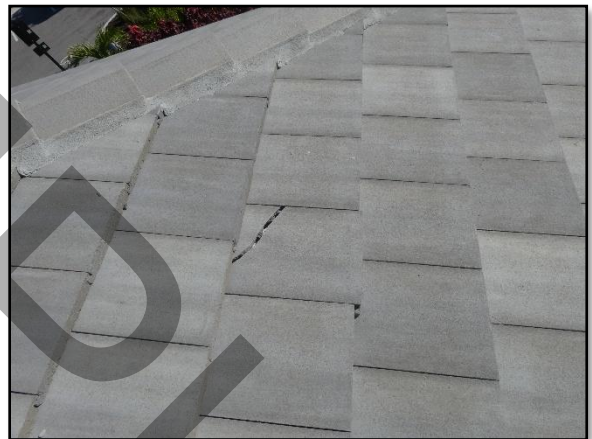
**Observation notes:** Miller Building Group aerially photographed all roofs via UAV. Isolated damaged tiles on pool cabana.

4 - Broken tile(s). M08\_(2213)

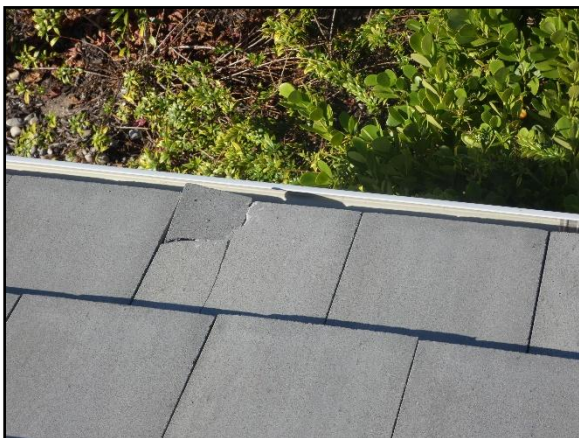
5 - Broken tile(s). M08\_(2218)

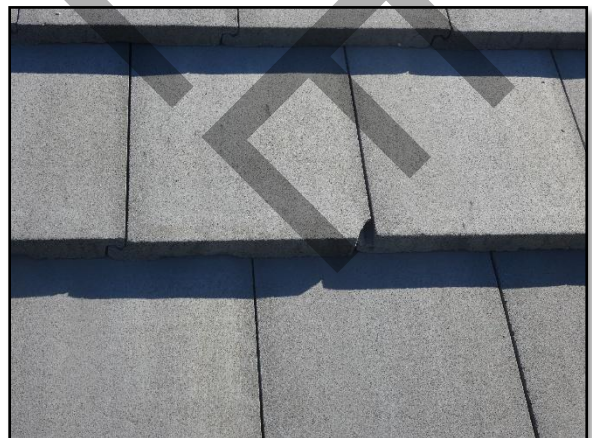
6 - Broken tile(s). M08\_(2224)

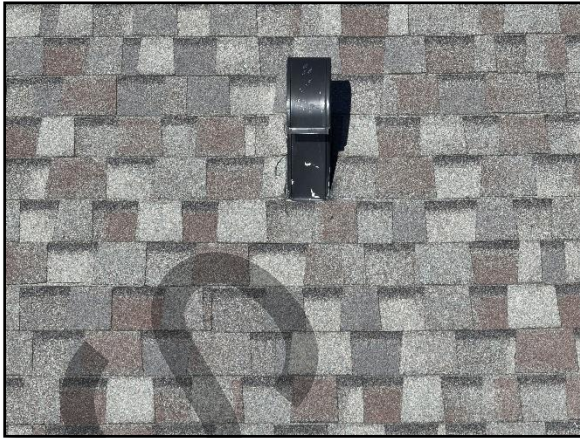
7 - Shingles over downside flange(s). M19\_UAV(1373)

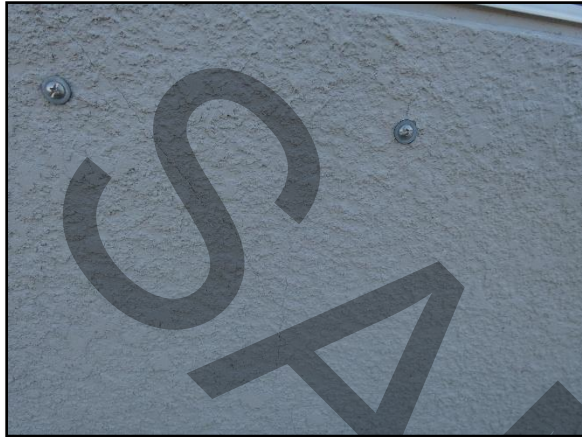
11 - Stucco cracks. M08\_(2376)

1B Structure	Routine Maintenance	No	Throughout	Stucco cracks	Chapter 25	Repair per PCA TN IS526 or ACI 524R-16.	M19_(1011), M19_(1291), M08_(2376), M08_(2418), M57_(351), M57_(427), M57_(656)

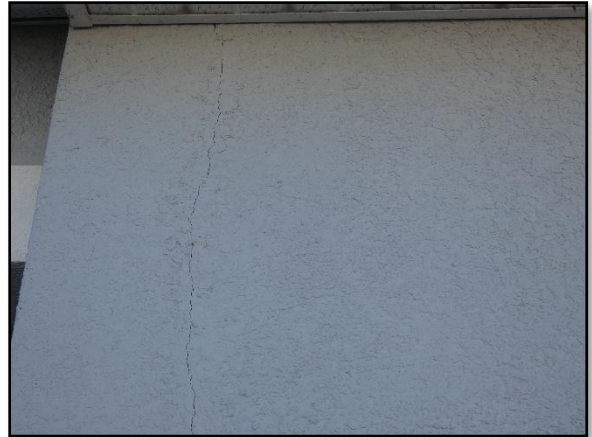
12 - Stucco cracks. M08\_(2418)

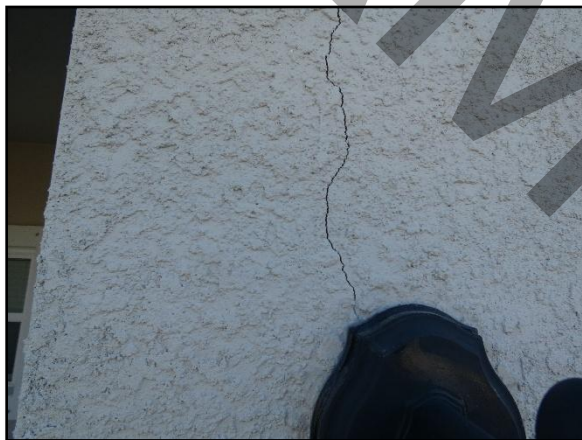
13 - Stucco cracks. M57\_(351)

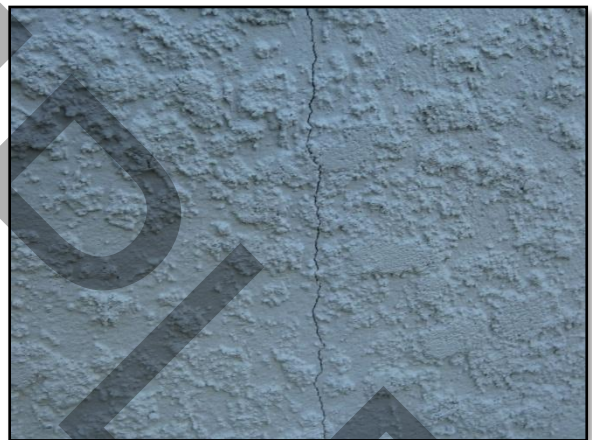
14 - Stucco cracks. M57\_(427)

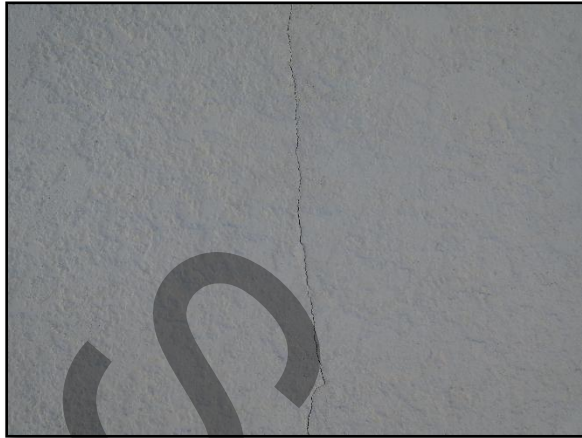
15 - Stucco cracks. M57\_(656)

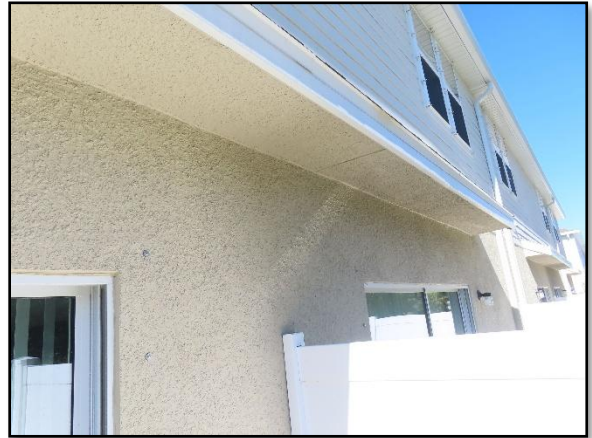
16 - Missing drainage accessory at horizontal / vertical transition. M19\_(1032)

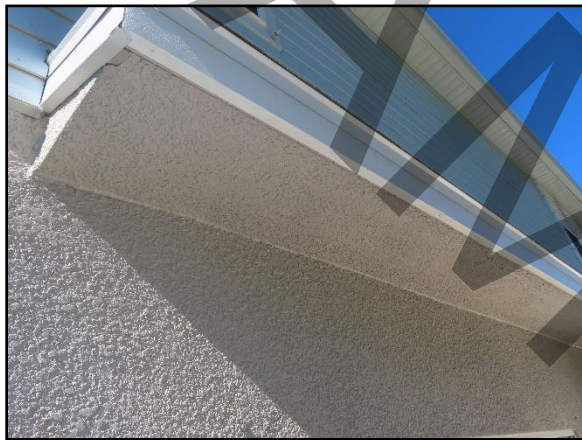
17 - Missing drainage accessory at horizontal / vertical transition. M19\_(1078)

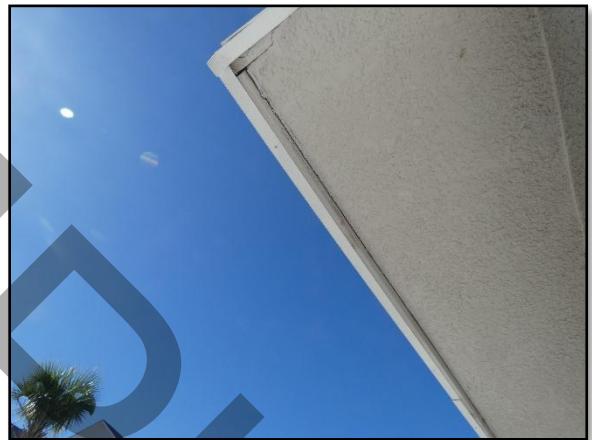
18 - Missing drainage accessory at horizontal / vertical transition. M08\_(2388)

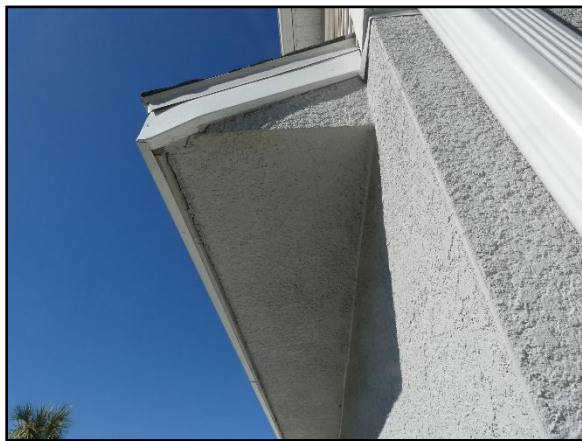
19 - Missing drainage accessory at horizontal / vertical transition. M08\_(2454)

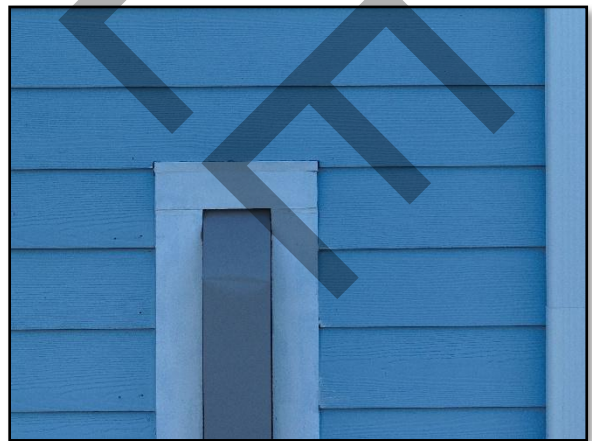
20 - Improper clearance at Z-flashing. M19\_UAV(1252)

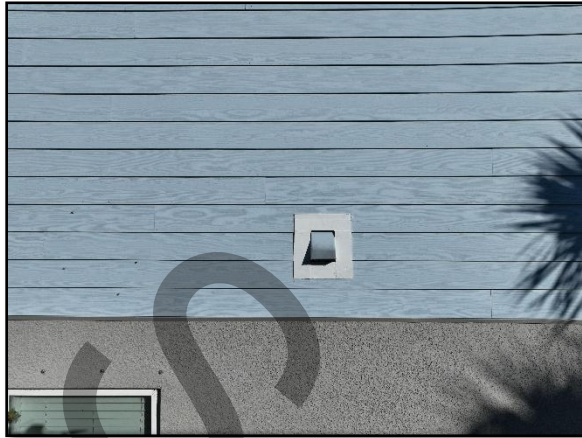
21 - Improper clearance at Z-flashing. M19\_UAV(1267)

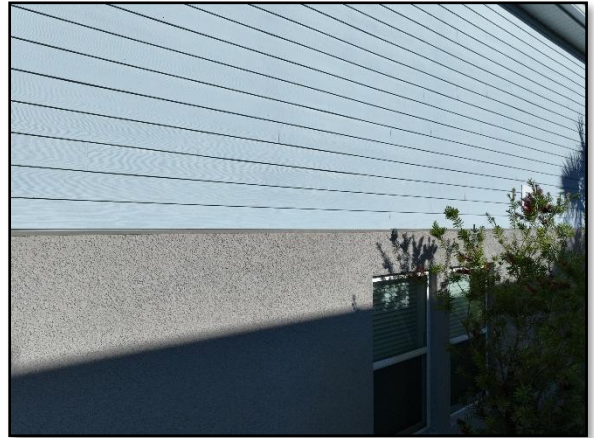
22 - Improper clearance at Z-flashing. M19\_UAV(1265)

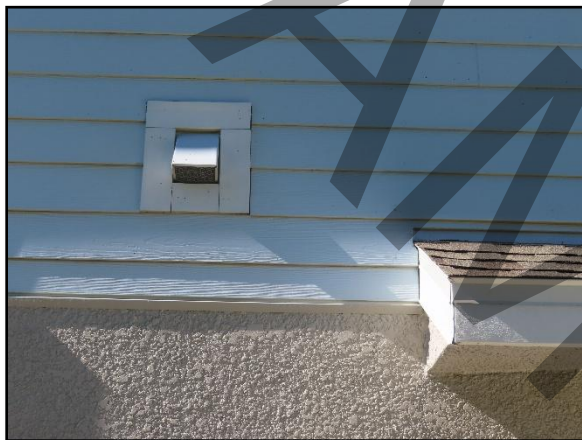
23 - Improper clearance at Z-flashing. M19\_(1076)

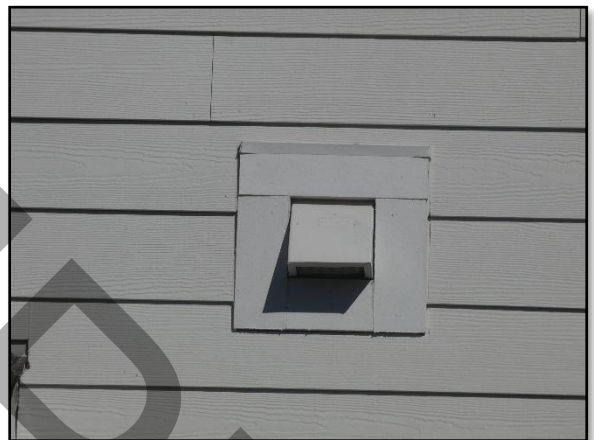
24 - Improper clearance at Z-flashing. M08\_(2396)

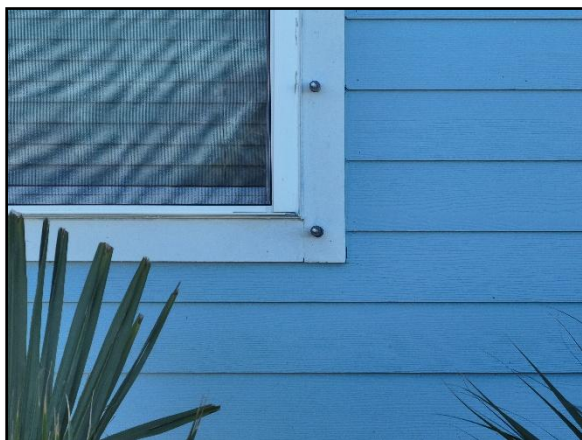
25 - Missing sealant at siding joints. M19\_UAV(1238)

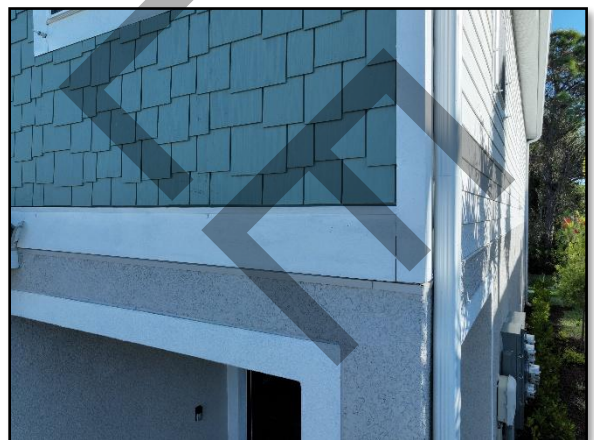
26 - Missing sealant at siding joints. M19\_UAV(1303)

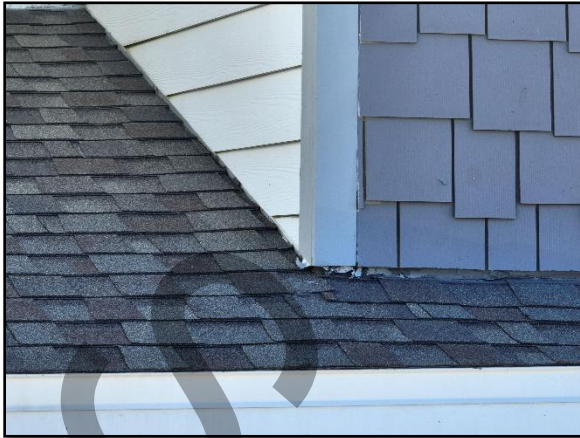
27 - Missing sealant at siding joints. M19\_UAV(1645)

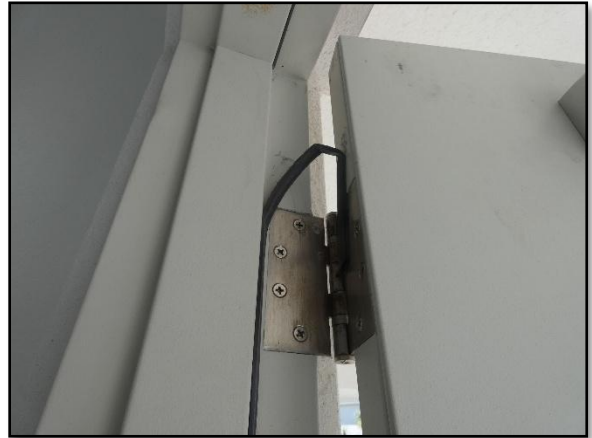
28 - Damaged weatherstripping. M08\_(2121)

Condition Section	Condition Type	Life Safety	Location:	Description	FBC Reference	Repair Recommendation(s)	Representative Photo Numbers
1B Structure	Construction	No	Throughout	Missing drainage accessory at horizontal / vertical transition	Chapters 14 and 25	Install a drainage accessory where missing.	M19_(1032), M19_(1078), M08_(2388), M08_(2454)
1B Structure	Construction	No	Throughout	Improper clearance between siding and Z-flashing	Chapter 14, Manufacturer's Installation Instructions	Trim boards to leave a minimum 1/4" uncaulked gap above Z-flashing.	M19_UAV(1252), M19_UAV(1267), M19_UAV(1265), M19_(1076), M08_(2396)
1B Structure	Construction	No	Throughout	Missing sealant at siding joints	Chapter 14, Manufacturer's Installation Instructions	Install sealant at siding joints.	M19_UAV(1238), M19_UAV(1303), M19_UAV(1645)
1B Structure	Routine Maintenance	No	Pool Cabana	Damaged / missing weatherstripping	Maintenance	Replace weatherstripping to prevent air leakage.	M08_(2121), M08_(2135)

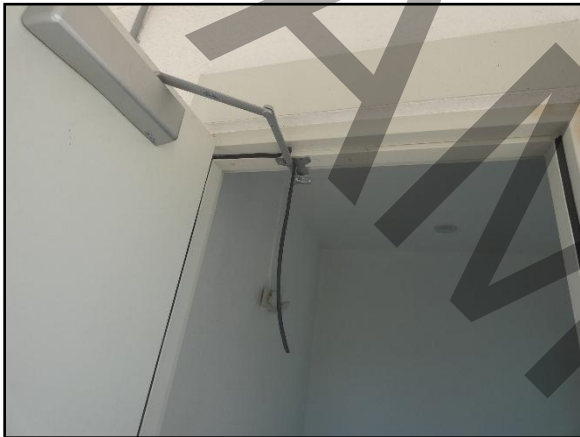
29 - Damaged weatherstripping. M08\_(2135)

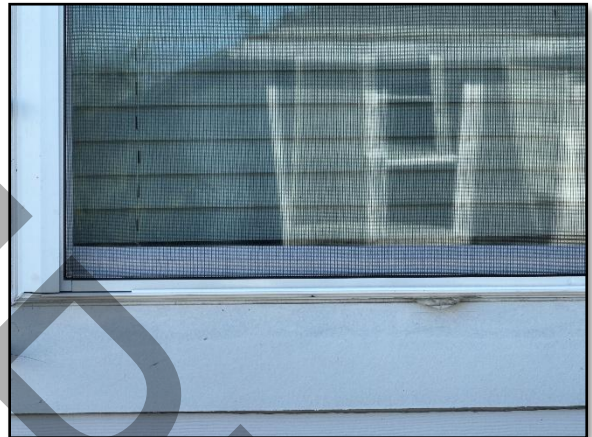
30 - Missing / deteriorated sealant. M19\_UAV(1295)

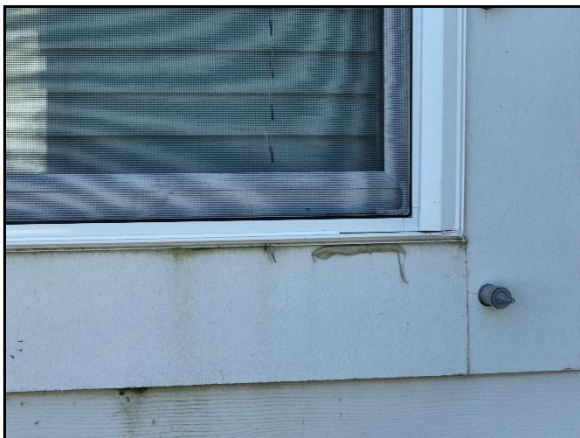
31 - Missing / deteriorated sealant. M19\_UAV(1424)

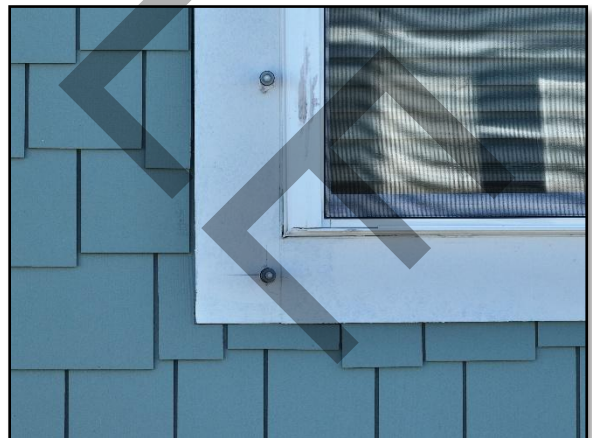
32 - Missing / deteriorated sealant. M19\_UAV(1296)

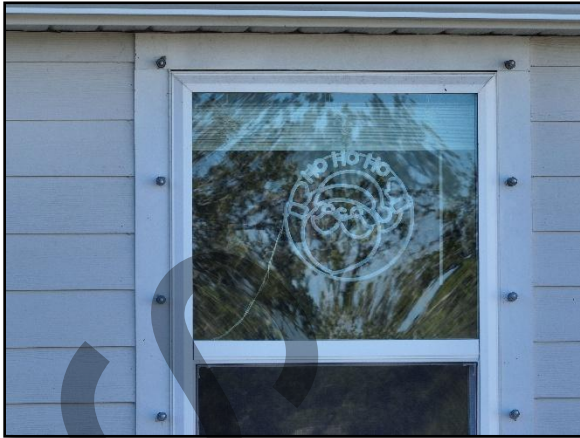
33 - Missing / deteriorated sealant. M19\_UAV(1347)

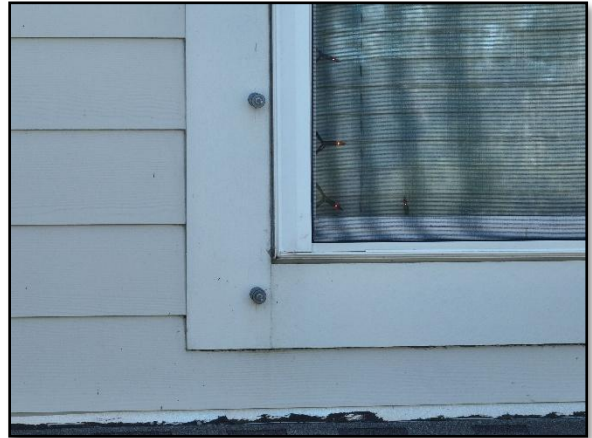
34 - Missing / deteriorated sealant. M19\_UAV(1409)

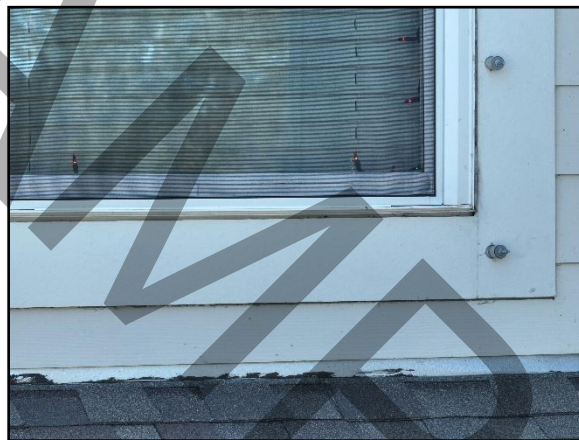
35 - Missing / deteriorated sealant. M19\_UAV(1410)

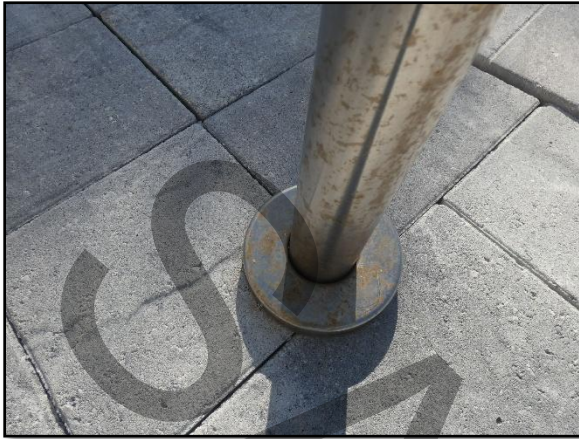
40 - Corroded escutcheon at handrail / ladder.  
M08\_(2007)

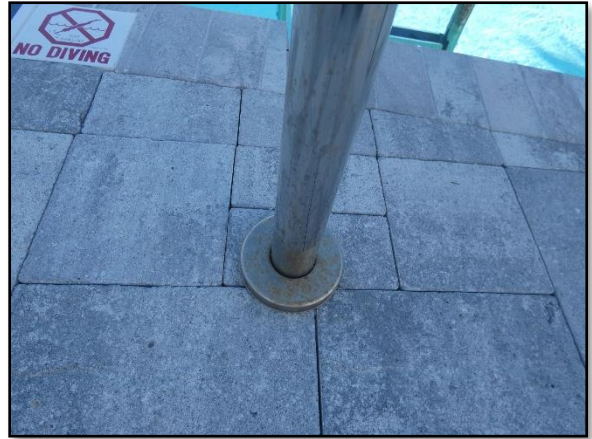
41 - Corroded escutcheon at handrail / ladder.  
M08\_(2030)

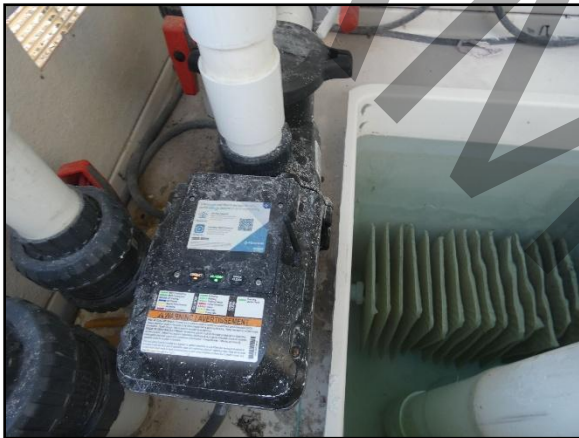
42 - Soiled equipment. M08\_(2169)

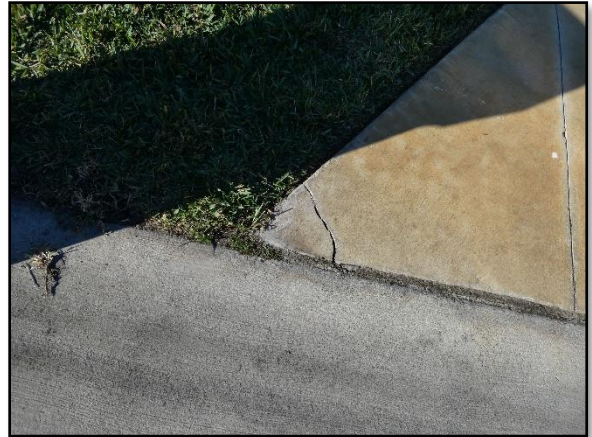
45 - Damaged driveway corner. M57\_(148)

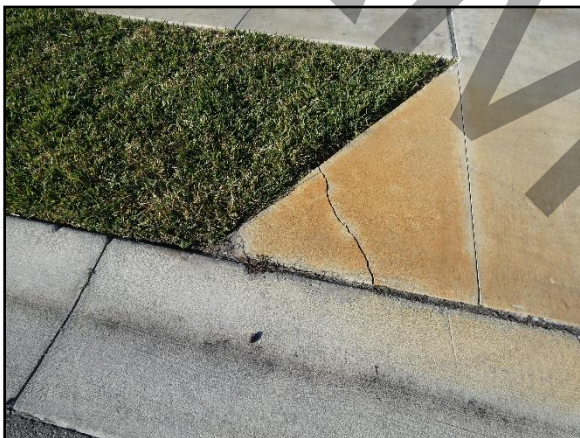
46 - Damaged driveway corner. M57\_(150)

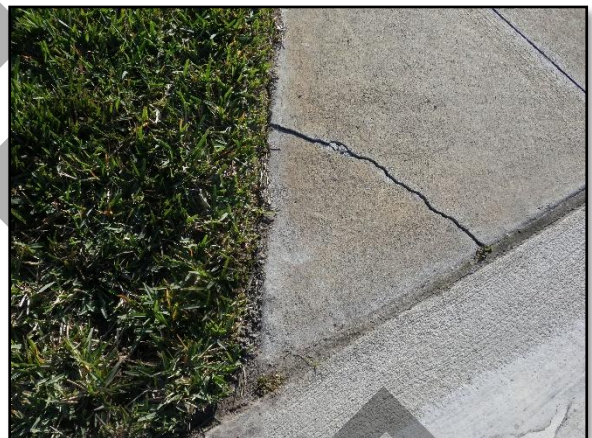
47 - Damaged driveway corner. M57\_(161)

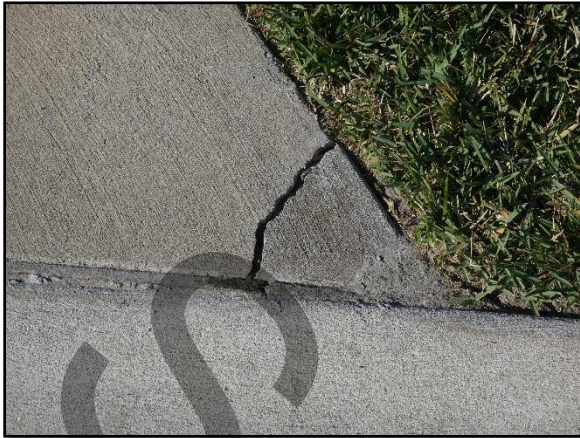
48 - Damaged driveway corner. M57\_(163)

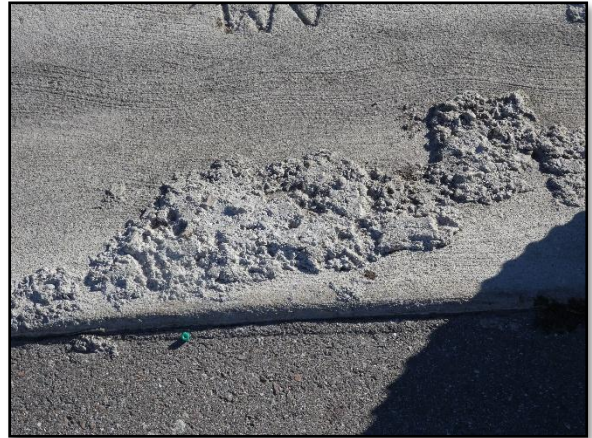
49 - Concrete spoil in gutter. M57\_(154)

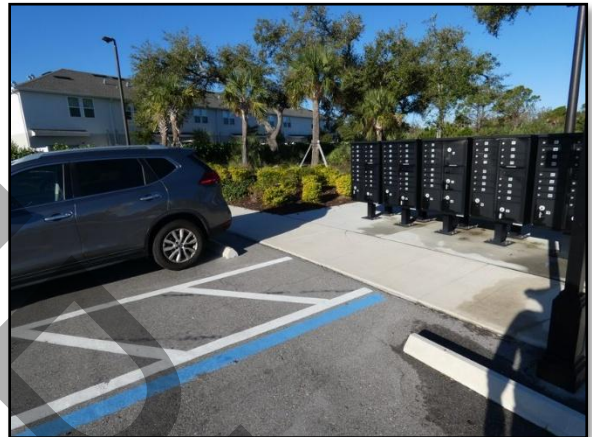
51 - Missing detectable warning. M57\_(140)

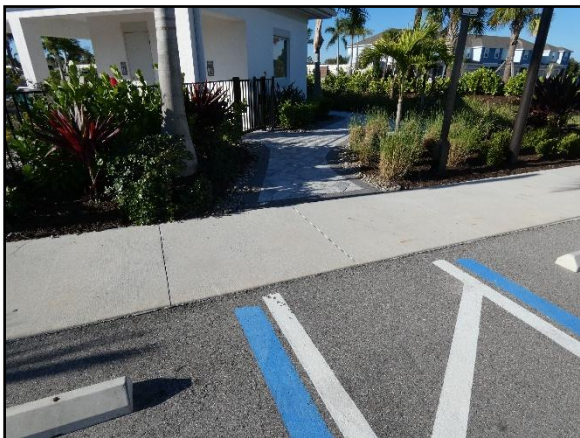
52 - Missing detectable warning. M57\_(190)

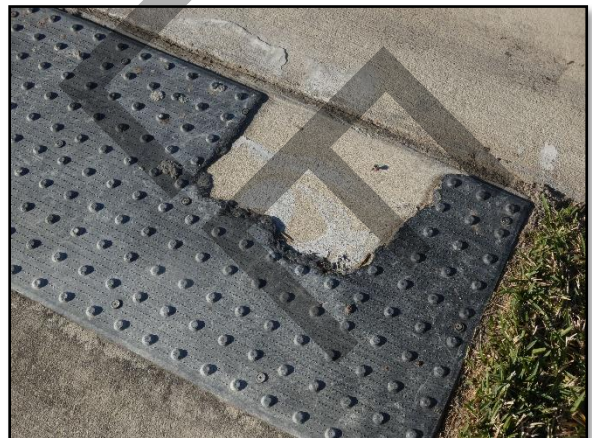
53 - Damaged detectable warnings. M57\_(159)

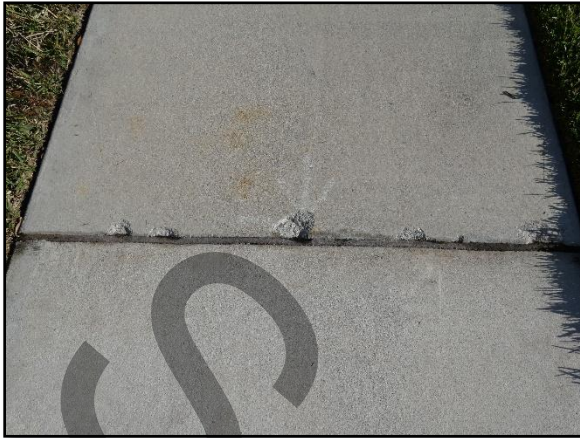
54 - Cracked / damaged sidewalk. M57\_(124)

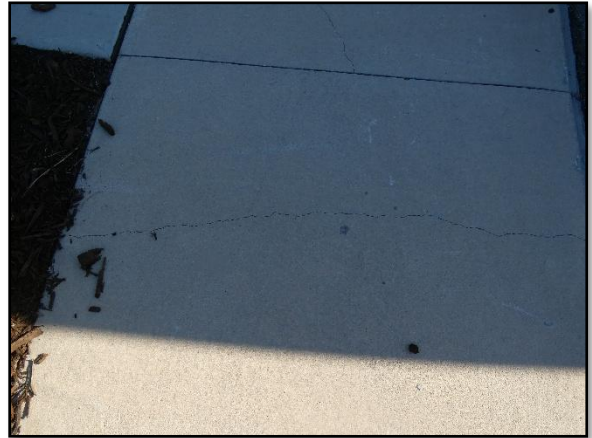
55 - Cracked / damaged sidewalk. M57\_(127)

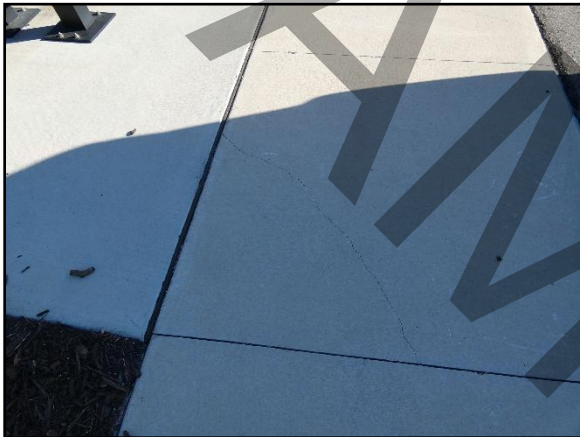
56 - Cracked / damaged sidewalk. M57\_(128)

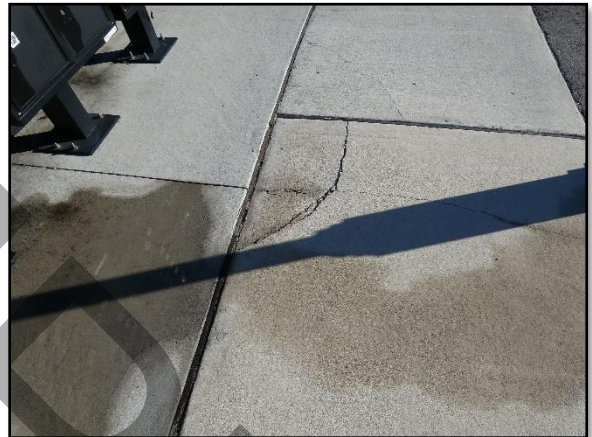
57 - Cracked / damaged sidewalk. M57\_(130)

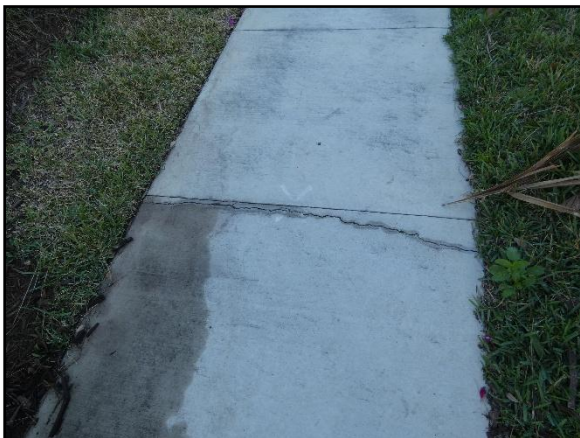
58 - Cracked / damaged sidewalk. M57\_(133)

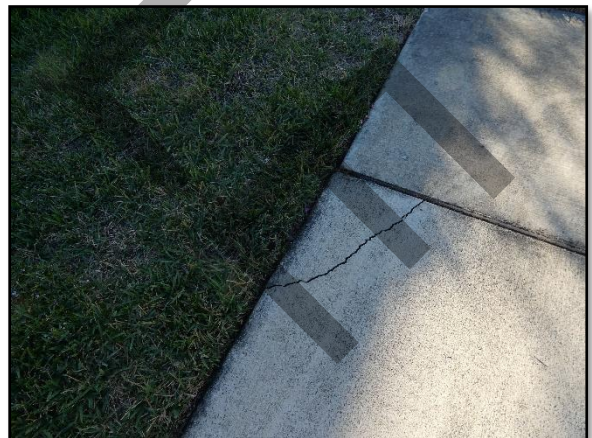
59 - Cracked / damaged sidewalk. M57\_(142)

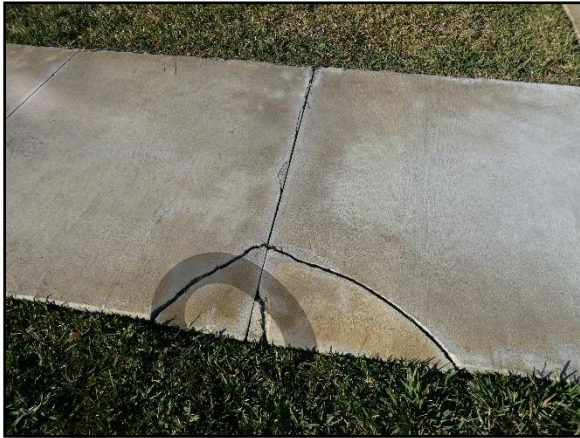
60 - Cracked / damaged sidewalk. M57\_(147)

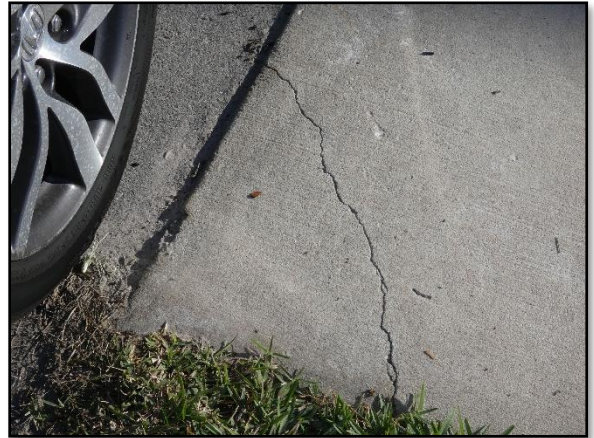
61 - Cracked / damaged sidewalk. M57\_(170)

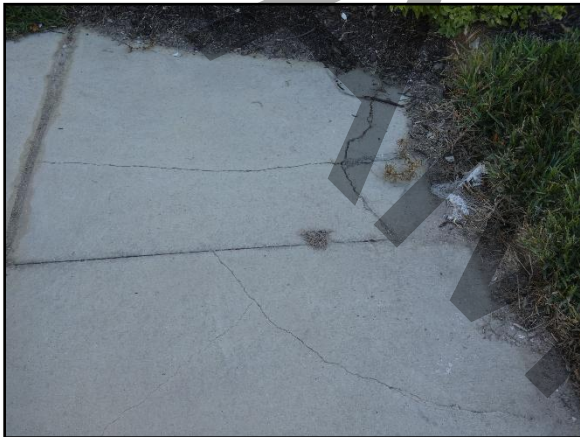
62 - Cracked / damaged sidewalk. M57\_(172)

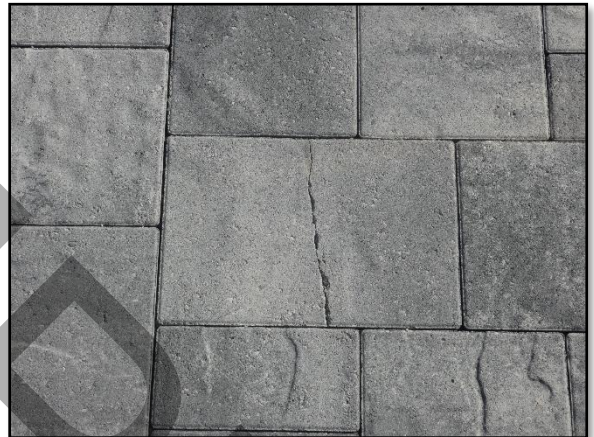
63 - Damaged / missing pavers. M08\_(2235)

2B Pavement	Routine Maintenance	No	Pool Cabana	Damaged / missing pavers	Maintenance	Replace damaged or missing pavers.	M08_(2235)
2B Pavement	Corrective Maintenance	Yes	Pool Cabana	Uneven / sunken / displaced pavers	Maintenance	Reset sunken or displaced pavers.	M08_(2035), M08_(2233)

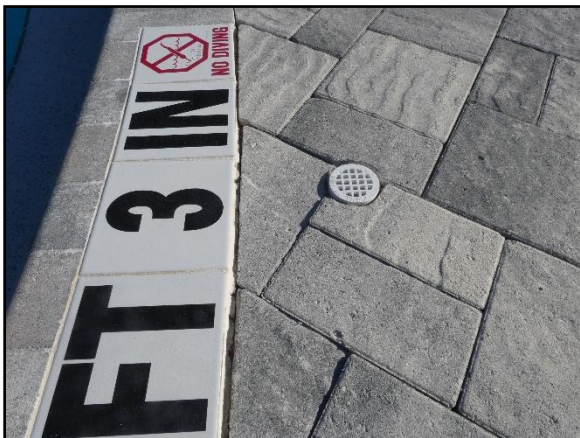
64 - Uneven / sunken / displaced pavers. M08\_(2035)

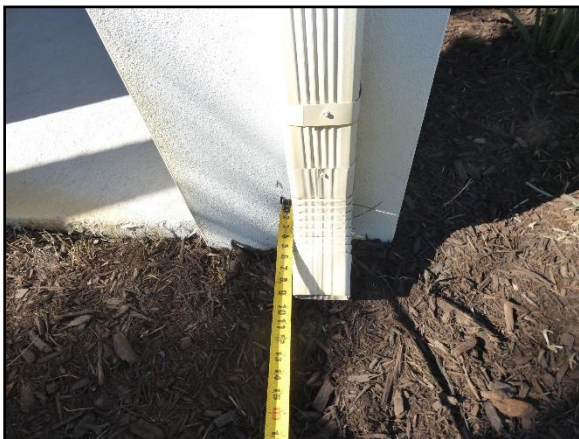
74 - Improper discharge of gutter downspout.  
M08\_(2527)

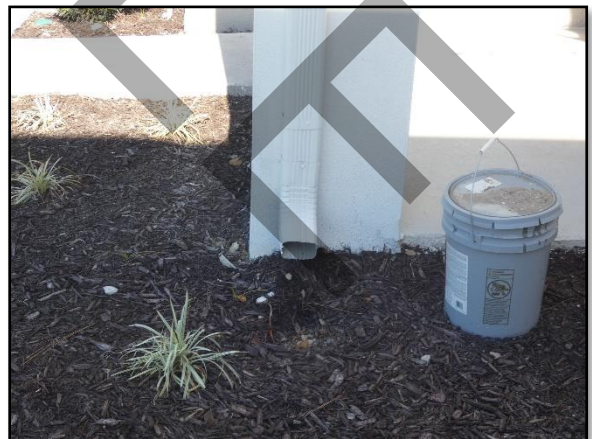
75 - Improper discharge of gutter downspout.  
M08\_(2545)

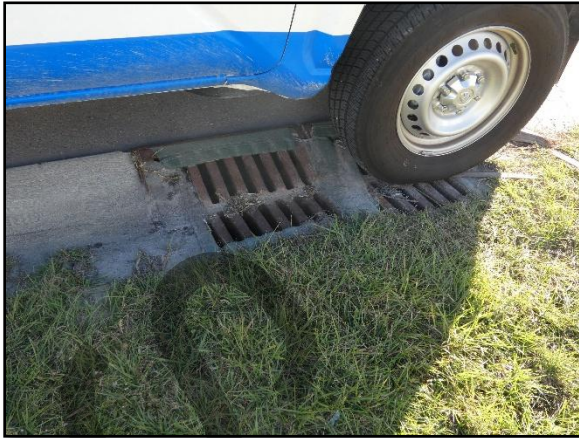
76 - Damaged / missing filter fabric. M57\_(165)

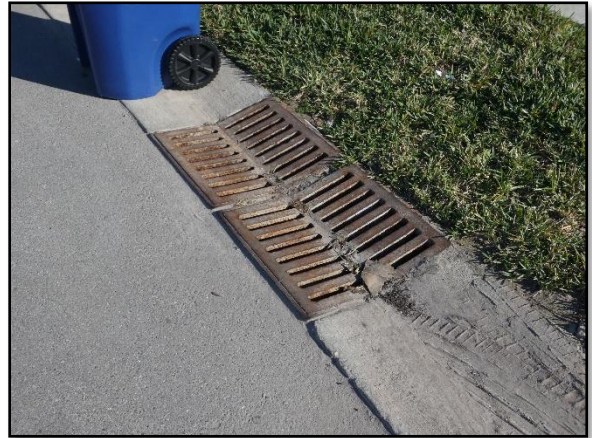
77 - Damaged / missing filter fabric. M57\_(167)

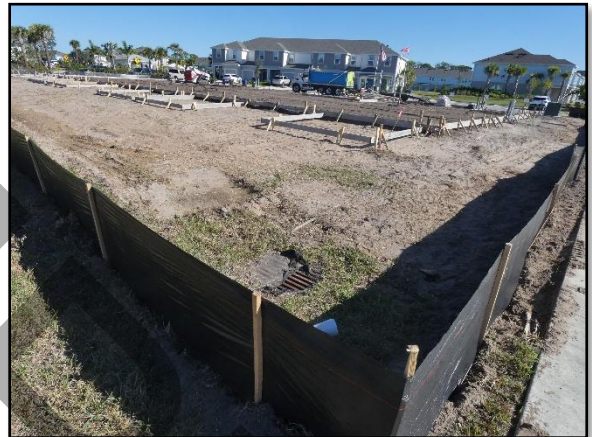
79 - Damaged / missing filter fabric. M08\_(2315)

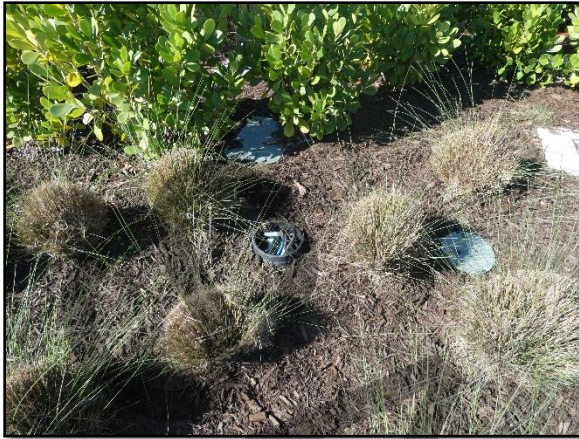
80 – Missing valve box / utility vault cover(s).  
M08\_(2295)

Condition Section	Condition Type	Life Safety	Location:	Description	FBC Reference	Repair Recommendation(s)	Representative Photo Numbers
2C Drainage	Corrective Maintenance	No	Throughout	Obstructed / debris at stormwater drain	Maintenance	Remove all vegetation and debris from drain.	M08_(2352), M08_(2394), M08_(2404), M19_(1066), M19_(1067), M19_(1023), M57_(1154), M57_(1166)
2C Drainage	Construction	No	Building 20, 10	Improper discharge of gutter downspout	Chapter 15	Adjust to discharge 12" away from building either by means of extensions, splash blocks or underground piping.	M08_(2527), M08_(2545)
2C Drainage	Maintenance	No	Building 24	Damaged / missing filter fabric	Chapter 33	Install filter fabric.	M57_(165), M57_(167), M57_(188), M08_(2315)
2D Landscaping	Corrective Maintenance	Yes	Pool Cabana, Building 8	Missing valve box / utility vault cover(s)	Maintenance	Replace valve box cover.	M08_(2295), M19_(1094)

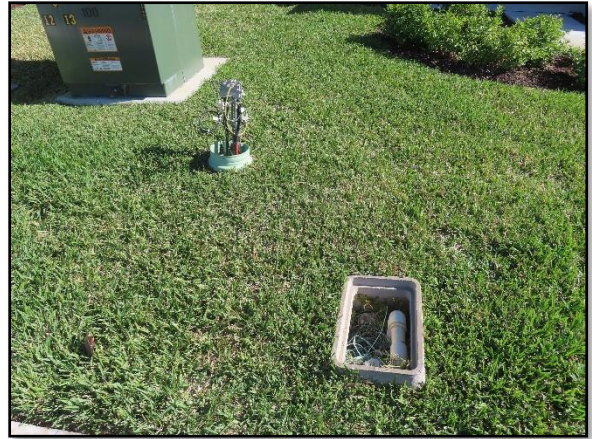
81 – Missing valve box / utility vault cover(s).  
M19\_(1094)

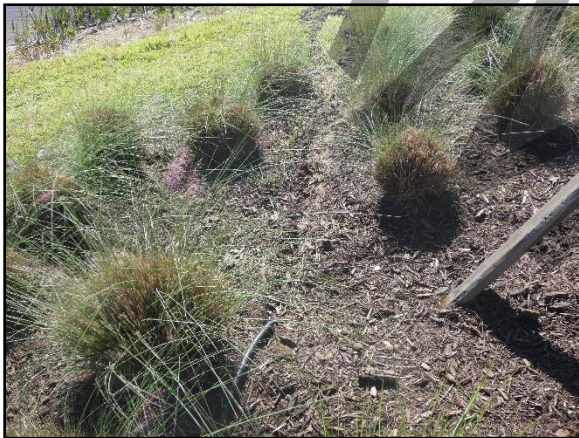
82 – Washout from irrigation. M08\_(2298)

2D Landscaping	Routine Maintenance	No	Pool Cabana	Washout from irrigation	Maintenance	Locate source of washout and repair.	M08_(2298)
2D Landscaping	Corrective Maintenance	No	Irrigation Pump	Evidence of leak	Maintenance	Repair leaking pump equipment.	M08_(2261)

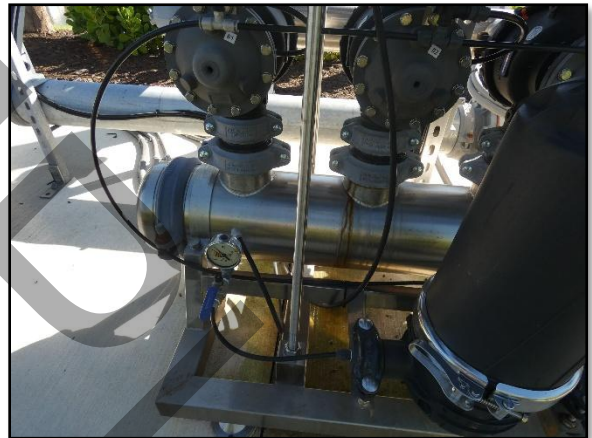
83 – Evidence of leak. M08\_(2261)

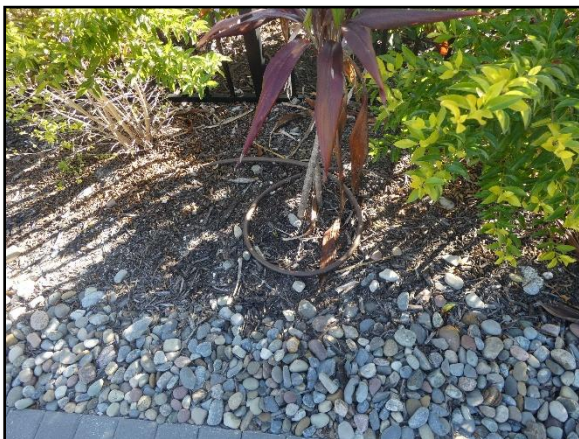
84 – Exposed drip lines and bubblers. M08\_(2039)

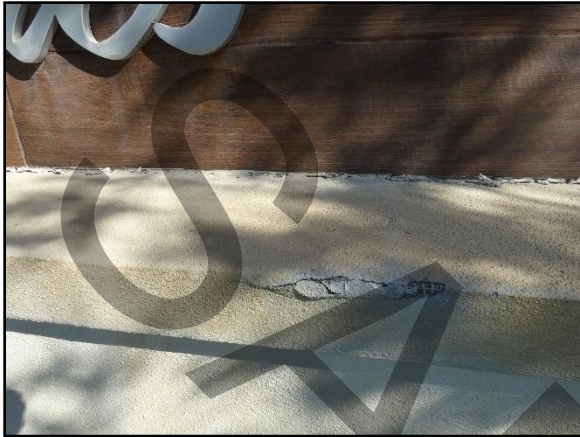
94 - Damaged concrete at entry monument.  
M08\_(2329)

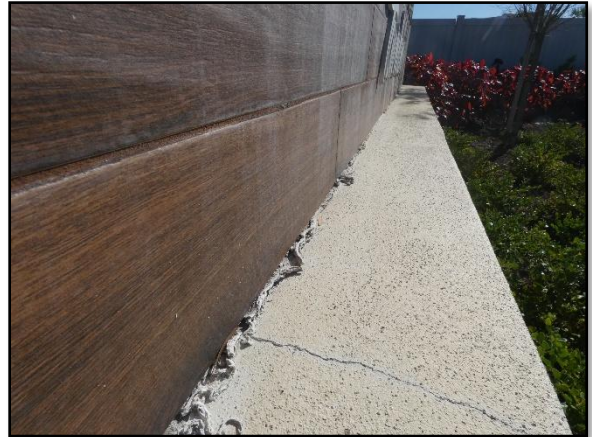
95 - Damaged concrete at entry monument.  
M08\_(2334)

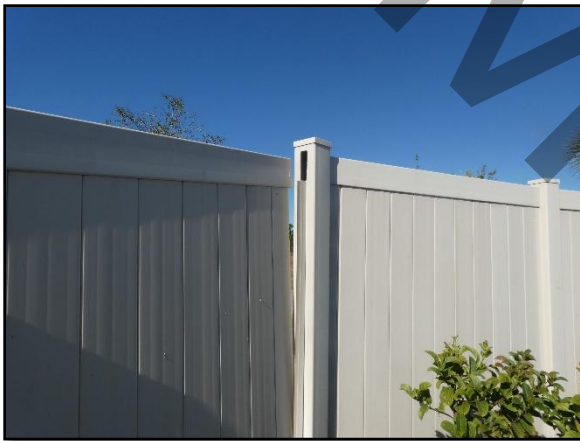
96 - Loose / disconnected / missing fencing section.  
M08\_(2320)

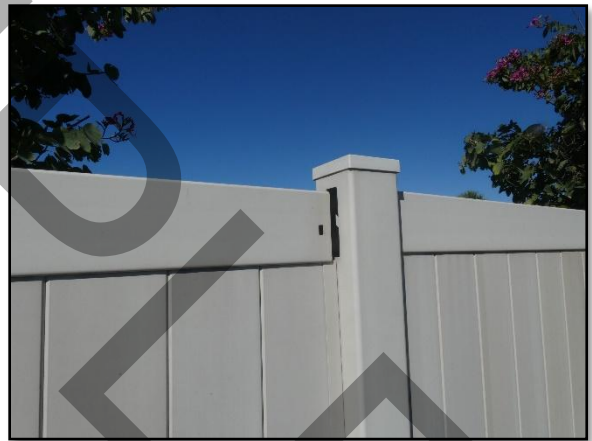
97 - Loose / disconnected / missing fencing section.  
M08\_(2323)

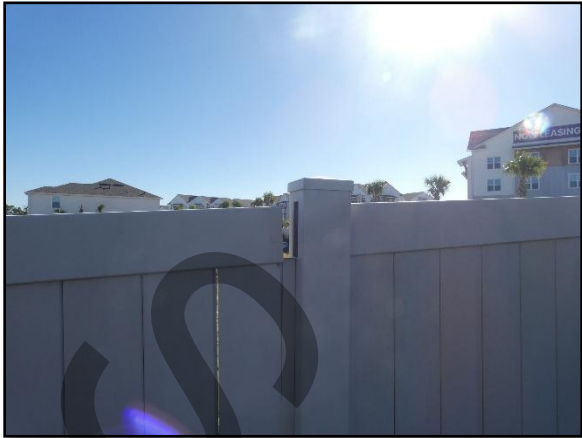
98 - Loose / disconnected / missing fencing section.  
M08\_(2340)

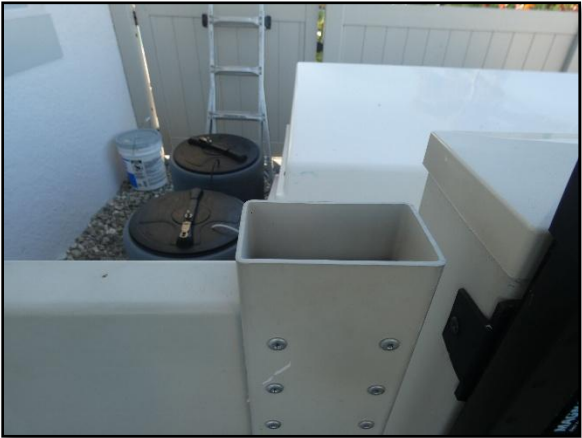
99 - Missing caps on fence post(s). M08\_(2065)

2D Landscaping	Routine Maintenance	No	Pool Cabana	Construction-related debris/ trash	Maintenance	Remove all trash / debris.	M08_(2023)
2E Community Walls	Routine Maintenance	No	Entry Monument	Damaged concrete at entry monument	Maintenance	Repair damaged concrete at entry monument.	M08_(2329), M08_(2334)
2E Community Walls	Routine Maintenance	No	Construction Entry	Loose / disconnected / missing fencing section	Maintenance	Secure loose fencing.	M08_(2320), M08_(2323), M08_(2340)
	Routine Maintenance	No	Pool Equipment	Missing caps on fence post(s)	Maintenance	Replace missing cap(s). Secure loose cap.	M08_(2065)
