# Limited Turnover Inspection Report

Re: **Community, Limited Turnover Inspection Report**  
Project Number: MXXXXX

Miller Building Group, LLC ("Miller Building Group") was retained by Client to perform a limited turnover inspection at the property commonly known as Community, located in XXXXX, Florida. This inspection was performed in accordance with the *Retention Agreement* dated Date (Appendix IV).

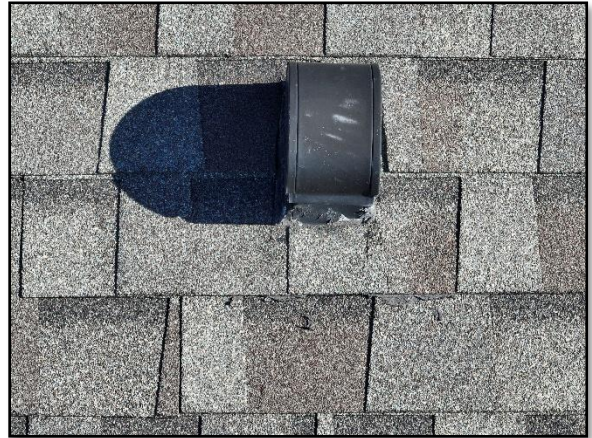
8 - Shingles over downside flange(s). M19\_UAV(1508)

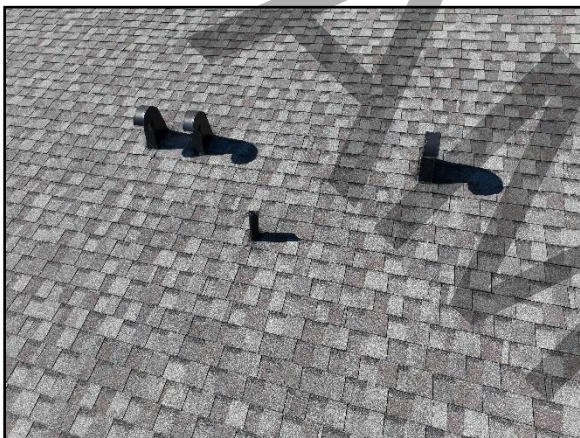
9 - Shingles over downside flange(s). M19\_UAV(1620)

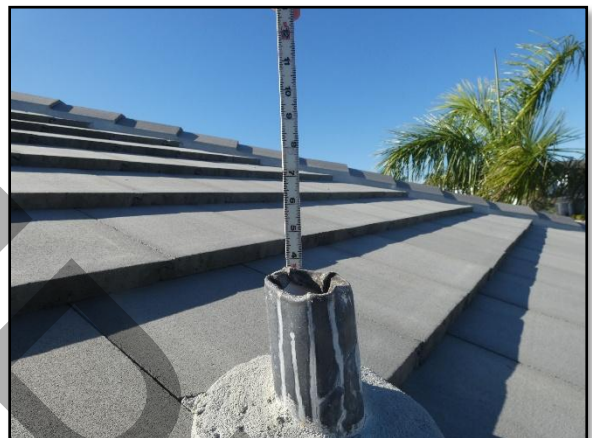
10 - Vent height less than 6" above roof deck.  
M08\_(2230)

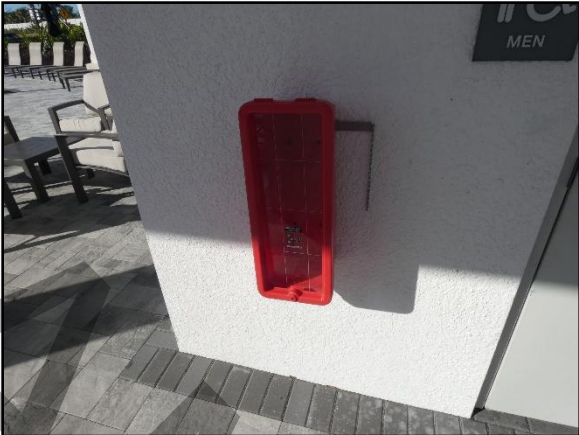
36 - Missing fire extinguisher. M08\_(2093)

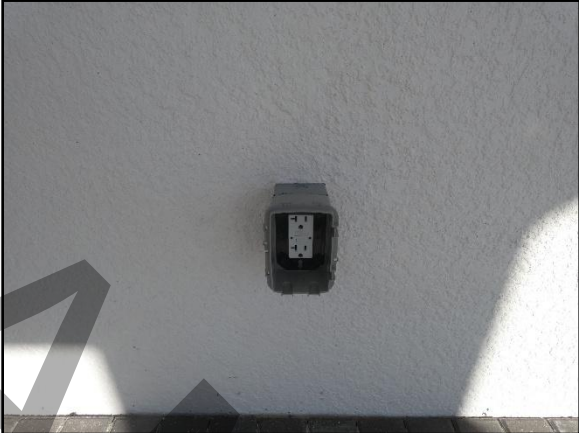
39 - Missing weatherproof electrical cover. M08\_(2084)

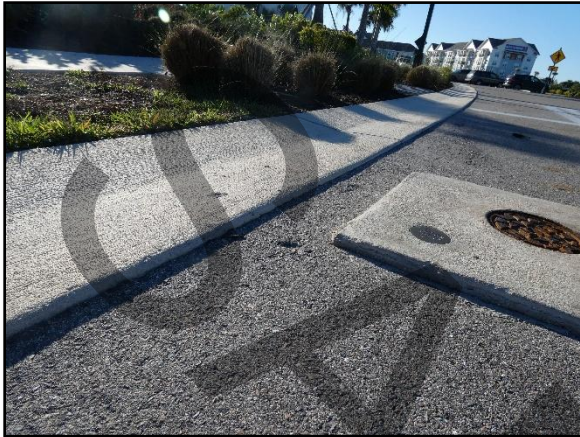
intersecting cracks. The final lift was not complete throughout the community at the time of observation.

44 - Final lift not completed. M57\_(103)

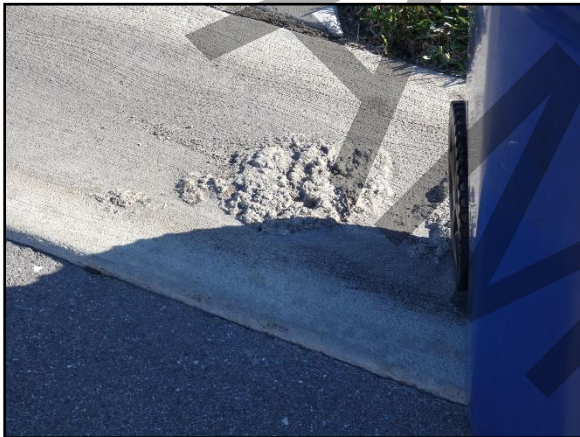
50 - Concrete in gutter. M57\_(155)

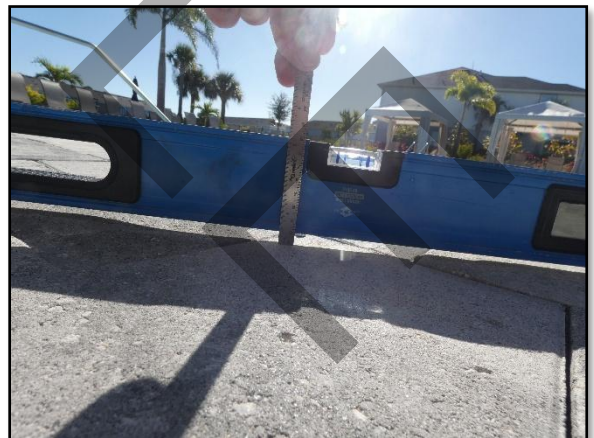
65 - Uneven / sunken / displaced pavers. M08\_(2233)

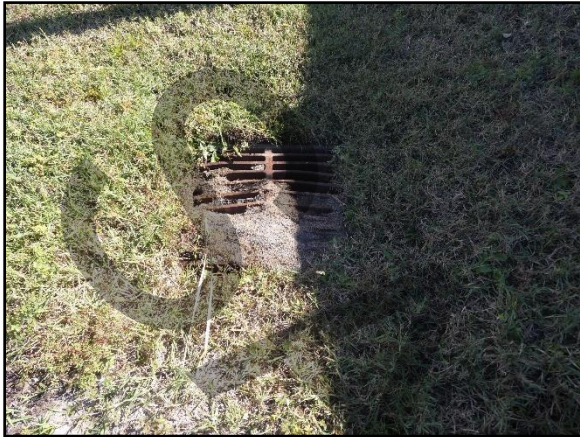
66 - Obstructed / debris at stormwater drain.  
M08\_(2352)

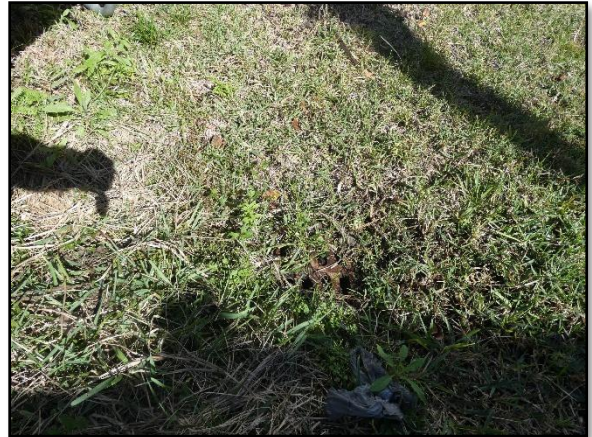
67 - Obstructed / debris at stormwater drain.  
M08\_(2394)

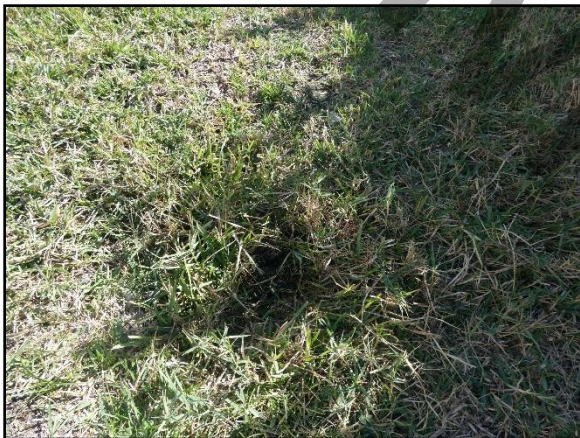
68 - Obstructed / debris at stormwater drain.  
M08\_(2404)

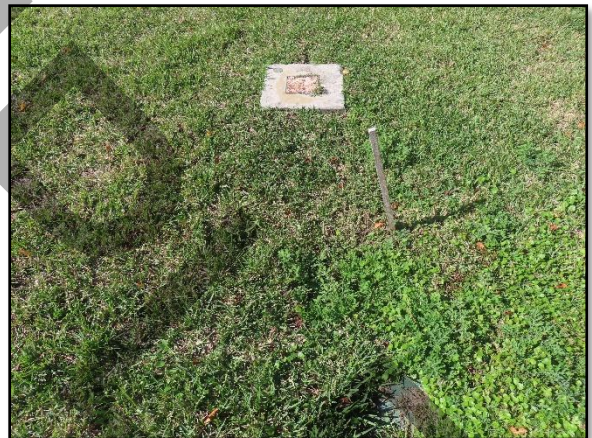
69 - Obstructed / debris at stormwater drain.  
M19\_(1066)

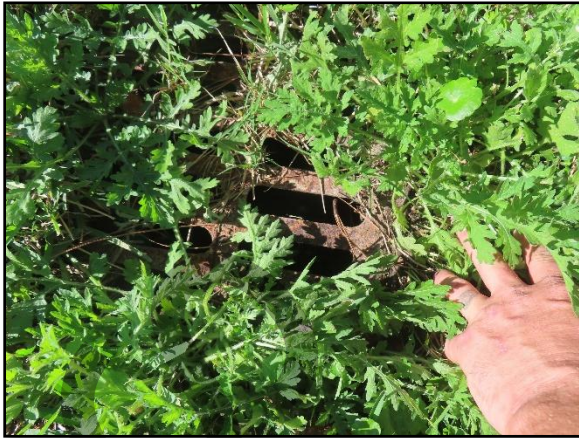
70 - Obstructed / debris at stormwater drain.  
M19\_(1067)

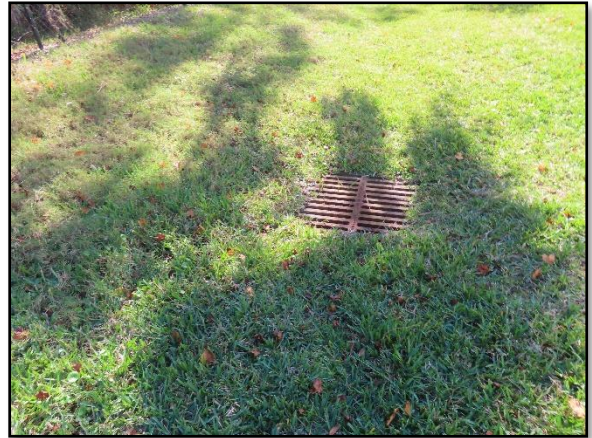
71 - Obstructed / debris at stormwater drain.  
M19\_(1023)

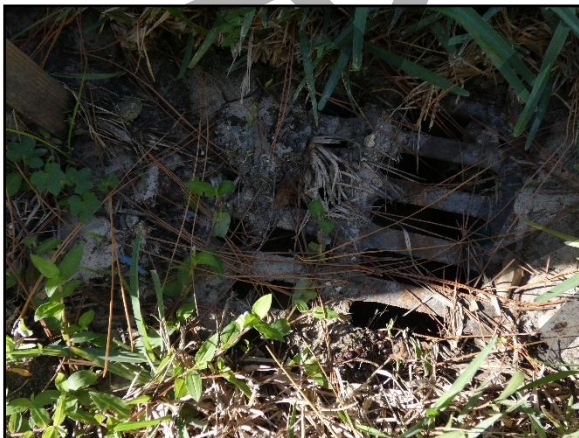
72 - Obstructed / debris at stormwater drain.  
M57\_(1154)

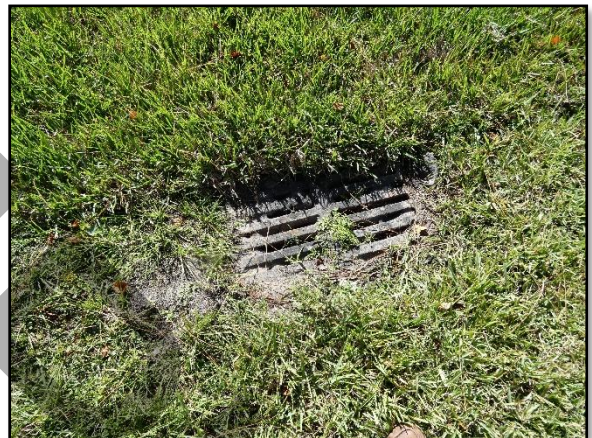
73 - Obstructed / debris at stormwater drain.  
M57\_(1166)

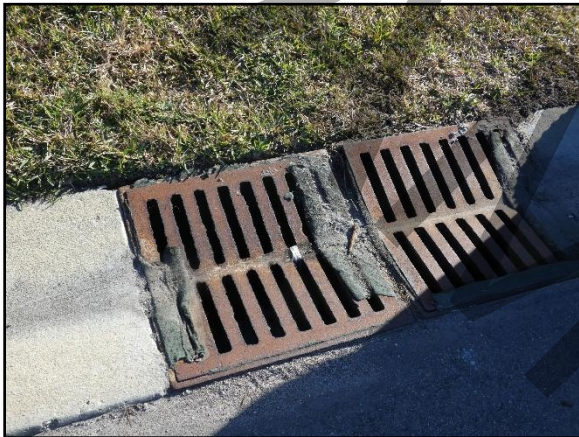
78 - Damaged / missing filter fabric. M57\_(188)

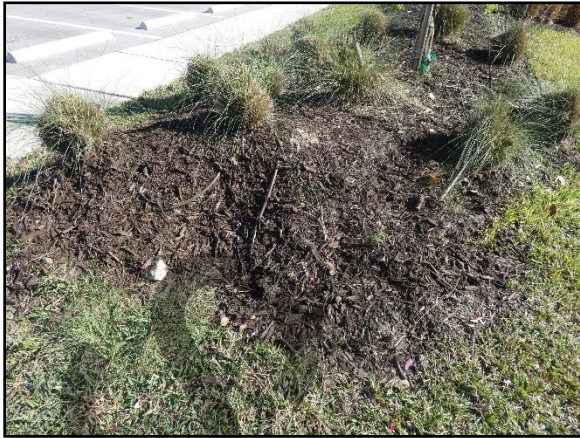
86 - Exposed drip lines and bubblers. M08\_(2303)

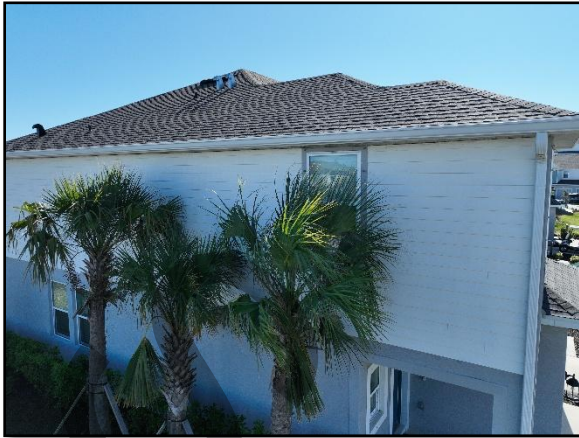
92 - Landscape touching building / structure / wall.  
M19\_UAV(1701)

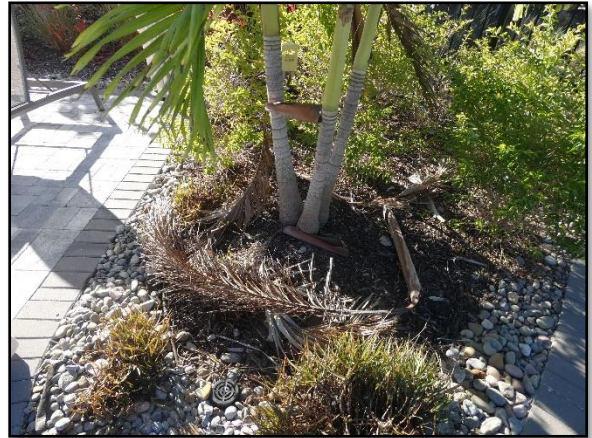
93 -Debris / trash. M08\_(2023)
