# Limited Turnover Inspection Report

Re: **Community, Limited Turnover Inspection Report**  
Project Number: MXXXXX

Miller Building Group, LLC ("Miller Building Group") was retained by Client to perform a limited turnover inspection at the property commonly known as Community, located in XXXXX, Florida. This inspection was performed in accordance with the *Retention Agreement* dated Date (Appendix IV).

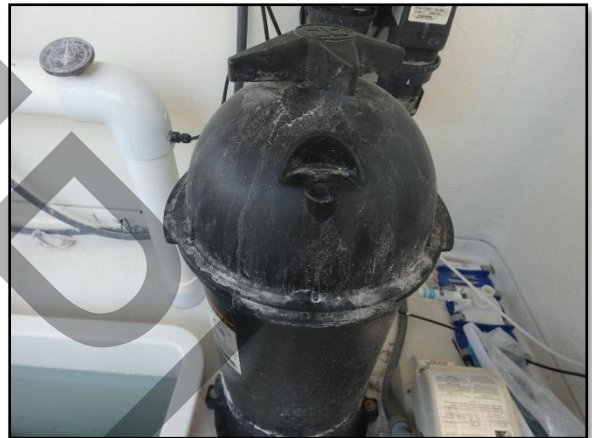
43 - Soiled equipment. M08\_(2182)

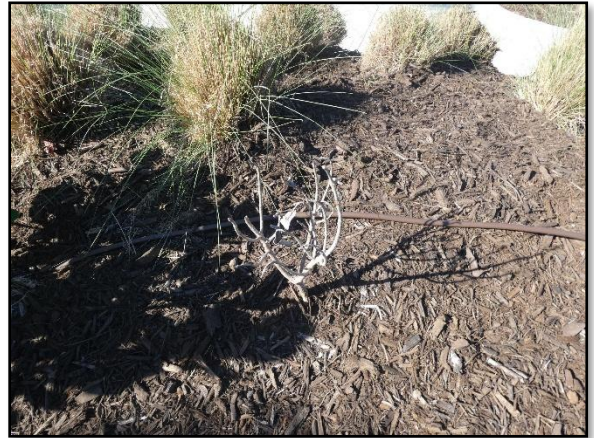
87 - Declining / dead landscape. M08\_(2285)

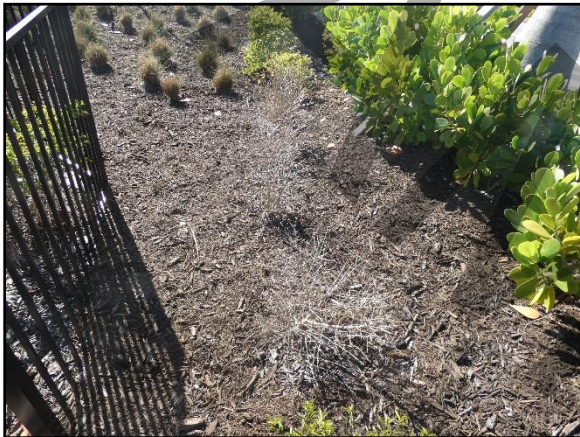
88 - Declining / dead landscape. M08\_(2291)

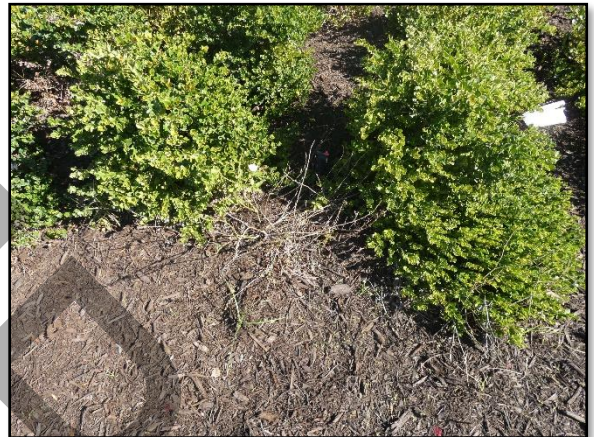
89 - Declining / dead landscape. M08\_(2328)
